A PICTORIAL STUDY OF

# SEISMIC DAMAGE

AND THE USE OF  
PROPER SAFEGUARDS.

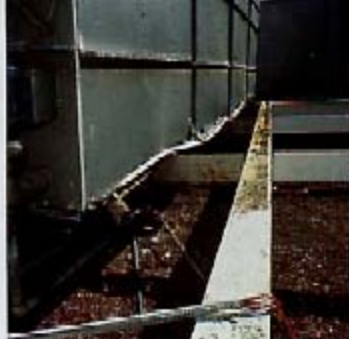
The independent rails rotated around their longitudinal axis, snapping anchor bolts and bending the cooling tower base. The problem could have been prevented by using a one piece structural base and double acting snubbers.

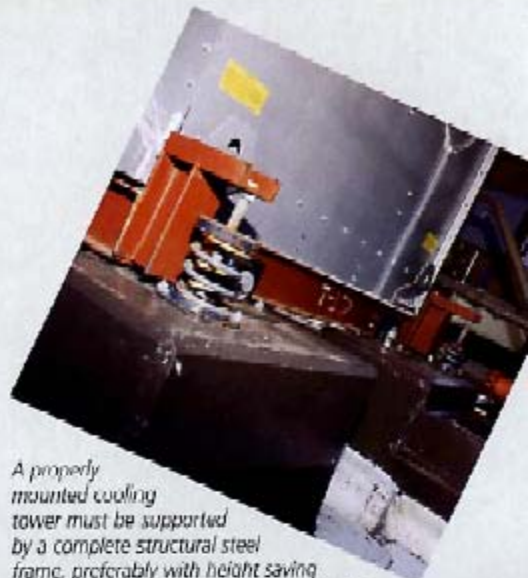
A properly mounted cooling tower must be supported by a complete structural steel frame, preferably with height saving brackets to lower the center of gravity. The five standing spring mountings need not be bolted down, as the blue all directional seismic snubbers next to each spring, limit the spring's motion. These all directional seismic snubbers are shown in Chapter 49 of the 1991 ASHRAE Guide Application Manual. Snubbers are double acting and selected for maximum calculated forces. Springs should be positioned within holders rather than welded to avoid cracking. Adequate edge distance to snubber anchor bolts is extremely important (Mason W/F Base, SLF Spring Mountings, Z-1225 Snubbers).

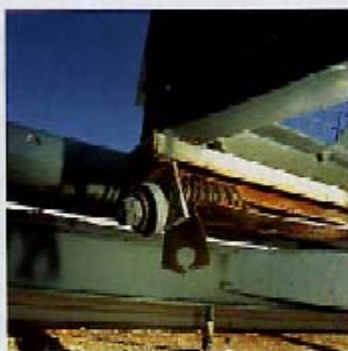
The vertical snubber bolt could not prevent the rail rotation. The anchor bolt tore through the base plate and the support springs fell over.

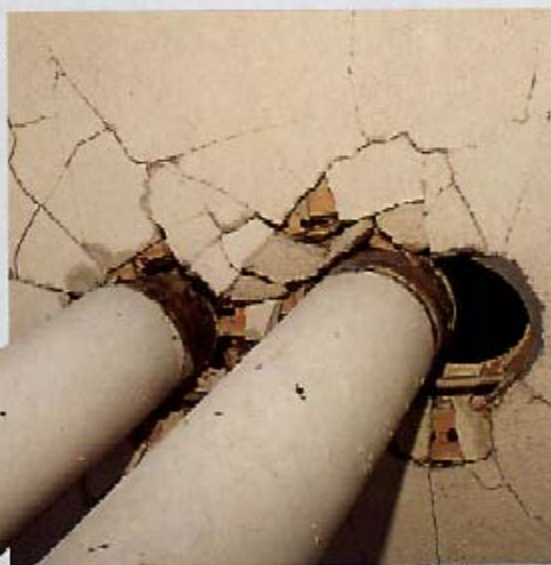
Improperly restrained piping can damage the structure itself. Unlike duct work, piping has mass and rigidity. Electrical lines in walls can be destroyed when piping shifts. Columns can be distorted and the structural integrity of bearing walls can be compromised as well.

This damage was caused by the relatively minor forces of  $0.15g_v$  and  $0.2g_H$ .

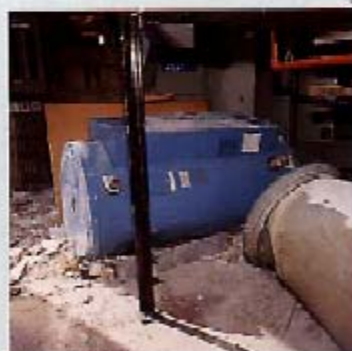
Water heaters have high centers of gravity and tend to turn over easily. The forces on this particular installation were  $0.15g_v$  and  $0.2g_H$ , heaters should be bolted to the floor and strapped to the nearest wall or column.

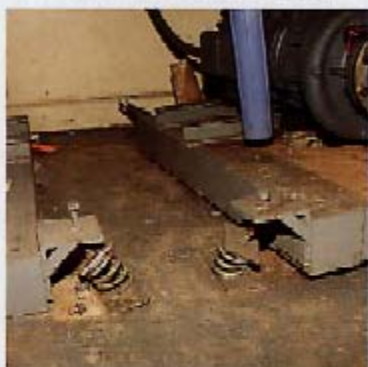
*It is unacceptable to consider the horizontal and vertical stiffness of a spring to resist earthquake forces. With no snubbers to limit motion the springs resonate and bend if not break, their attachments. Anchor bolts can bend or shear off when the springs themselves do not fail or fall over. The attachment of proper snubbers to the steel frame would have averted this disaster.*

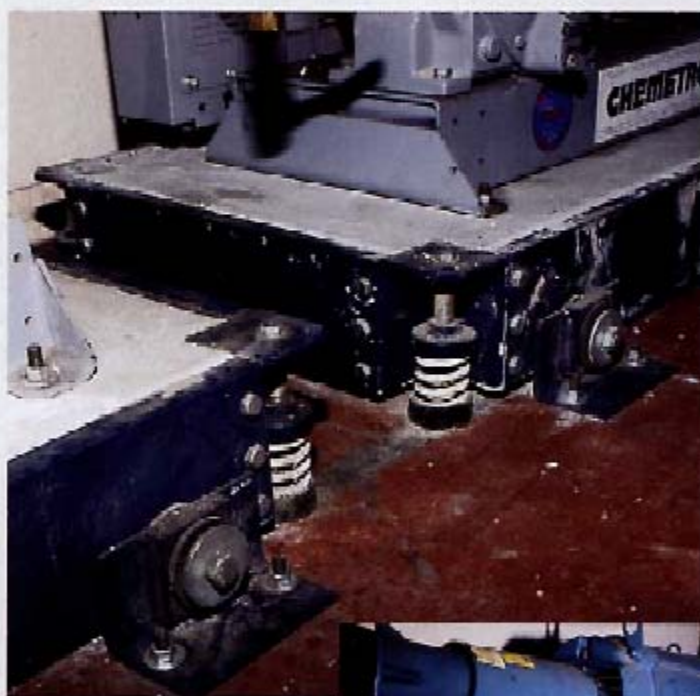
*Another example showing free standing springs cannot be used without snubbing devices. The anchor bolts under these spring mountings were too close to the edge, and broke the housekeeping pad. Forces were relatively low at 0.2gV and 0.25gH, but more than sufficient to create havoc on this unsnubbed, resonant system.*

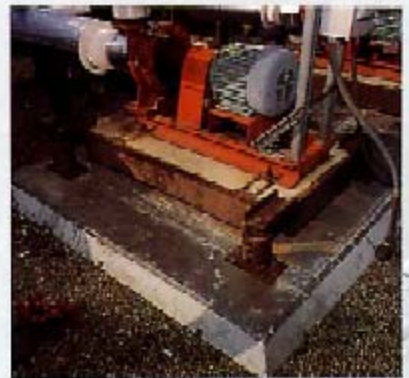
Mounting a pump directly on mountings without a supplementary steel or concrete base is bad practice because of pump coupling alignment problems when torque twists the bases. The mounting housings proved inadequate as the vertical restraining bolts failed. The restraining angles bent and either the anchor bolts were sized inadequately, of the wrong type or poorly installed as the anchorage broke free and the pump shifted out of position. Input was a low 0.2gV and 0.25gH.

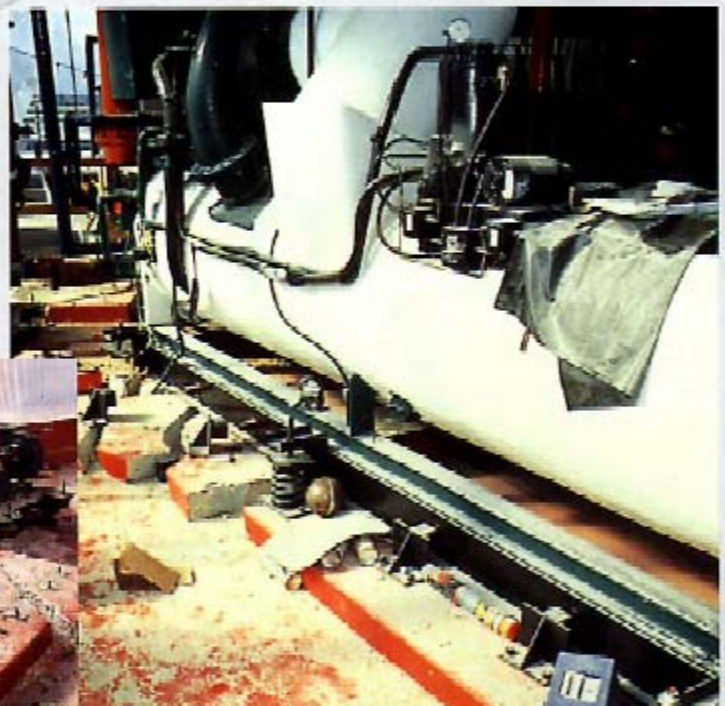
Housekeeping pad failures were common, because of improper doweling or fastening to the structural floor, and inadequate or no reinforcement in the pad itself. These pads, as the pads on the cover, had both problems. Inadequate fastening allows the pads to lift, chatter and shift. Poor reinforcement allows breakage. When the pads fail, the system must fail as nothing remains in place.

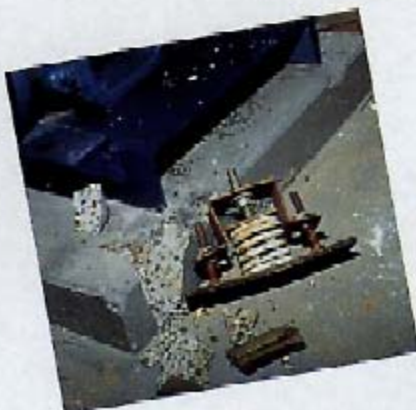
The anchor bolts were too close to the edge of the concrete housekeeping pad for the concrete to offer adequate resistance to the horizontal anchor bolt forces. The edges broke off so the anchor bolts were freed. This total failure of the restraint system occurred at only 0.15gV and 0.15gH. The mountings themselves showed considerable distortion as well.

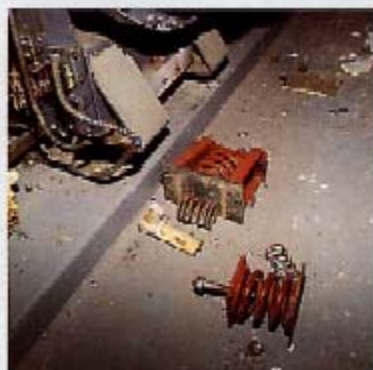
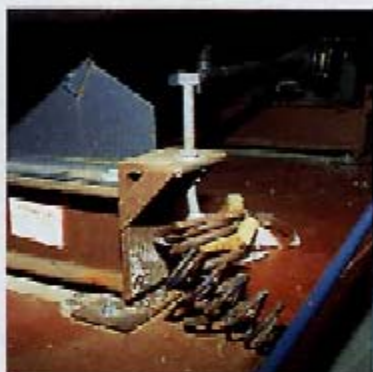
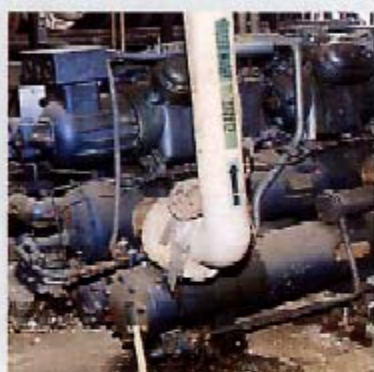
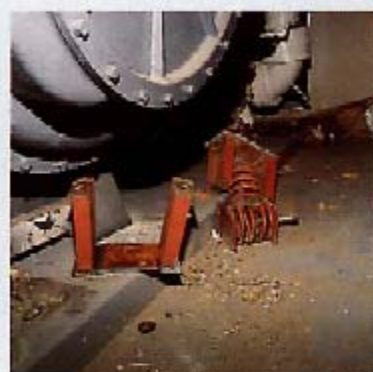
Rails rotated in virtually every application. In the upper photograph the rotation was initiated by the horizontal snubber pushing against the web of the beam. In both photographs the springs were secured by welding. Welding is always poor practice as the intense heat embrittles the spring so it tends to snap at the weld and scale incursions produce welds that pop off. All systems failed with pipe breakage in addition to the other problems.

Another example of gray iron mounting failure. Fragments shown in the lower left and lower righthand corners can be dangerous to building personnel as well as equipment. Not only is the compressor out of service, but there is the additional worry of potential liability and damage.

Some chillers can be directly mounted on spring isolators, but not as shown in photographs above. Seismic forces were reasonably high at 0.3gV and 0.6gH. Not all the parts are shown in the photographs, but both the restraining bolts between the upper and lower housings and the anchor bolts failed. The top plates came free of the rest of the housing and may still be attached to the chiller. Base plates were weak and showed distortion. Mountings rated by test with CSIMD pre-approval would have been far safer. The chiller dropped some 14" in addition to shifting.

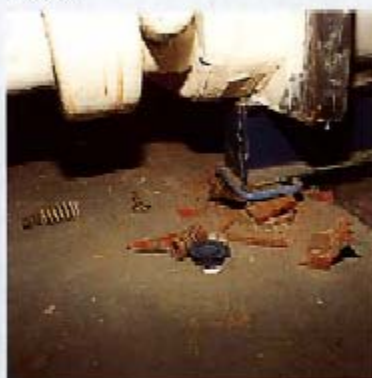
This photograph is a close up of the spring and all directional snubber installation below. The anchor bolts and the clearances from the edge of the housekeeping pad were all carefully calculated. (Mason WF Base, SLF Springs, Z-1011 Snubbers)

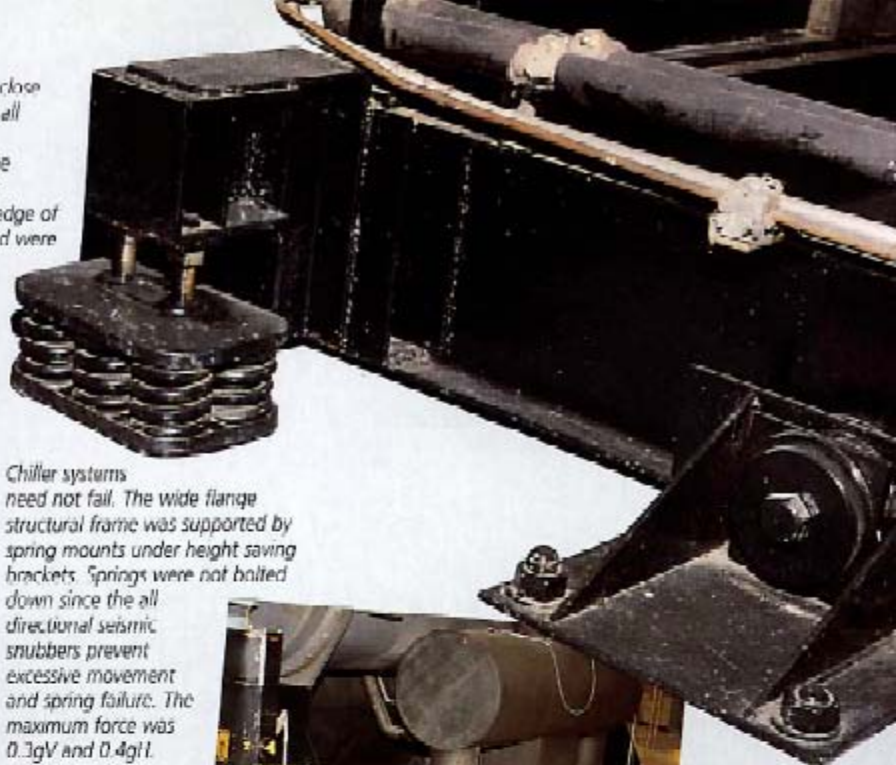
Chiller systems need not fail. The wide flange structural frame was supported by spring mounts under height saving brackets. Springs were not bolted down since the all directional seismic snubbers prevent excessive movement and spring failure. The maximum force was 0.3gV and 0.4gH.

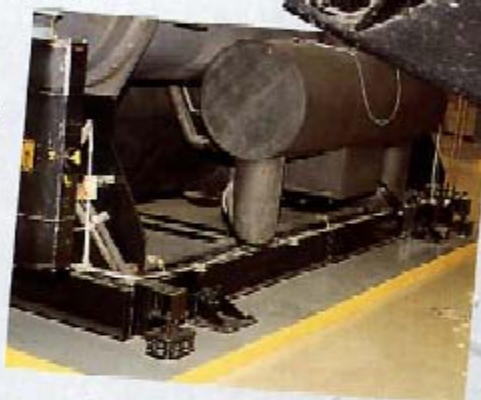
This is an excellent installation using a structural steel frame with height saving brackets and spring mounts with their own built in seismic protection. These are not malleable or gray iron, but ductile castings that will not shatter. The air cooled chiller has very light sheet metal legs which did not buckle, because the steel frame tied the four legs together. This unit was almost at the epicenter of the earthquake and saw seismic inputs of 1.0gV and 1.4gH. These are some of the highest forces ever recorded by an instrument anywhere in the world, but the installation survived intact. (Mason WF Base, SSLH Snubbed Spring Mountings)

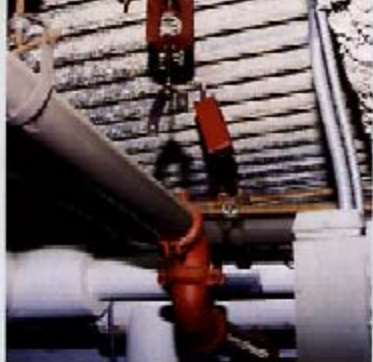
The clevis hanger in the center of the photograph fell apart and the rear hanger clevis is sufficiently displaced to have bent the ceiling bolt. There are chatter marks on the pipe in the front clevis, all indicating that this system went into resonance even though the accelerations were only 0.15gV and 0.2gH. Proper sway bracing, axial restraint and upper limit stops could have prevented this damage.

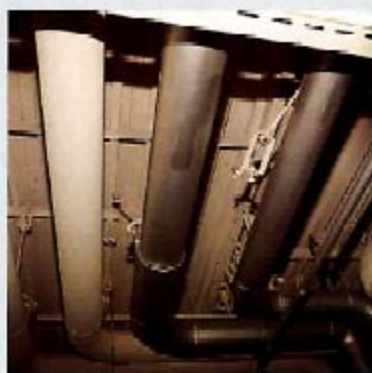
Piping without sway braces will shift position and change elevation. One hanger broke completely free and one pipe is displaced approximately 12" from its original location. On other jobsites, piping systems came down. Sway bracing and axial restraint is essential along with vertical limit stops at anchorage locations. Clevis bolts must be sleeved or braced as well.

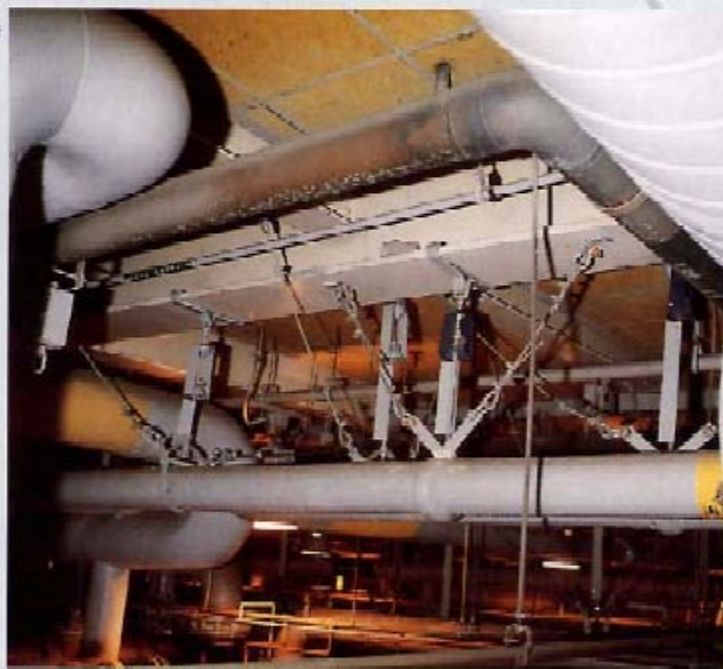
Piping with cable sway bracing survives an earthquake with no damage and no distortion. Forces in this area were high at 0.9gV and 1.2gH.

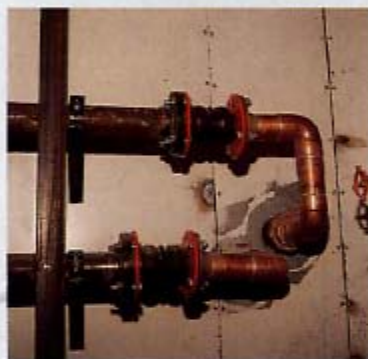
The metal flexible hose prevented pipe failure. However, the metal hose on the right was compressed. Braided metal hoses cannot accept compression and it had to be replaced. Flexible metal joints do not have the same movement capabilities as rubber joints, and tend to fail under seismic conditions. The seismic input was 0.15gV and 0.2gH. (Recommendation: Mason Safeflex SFDEI)

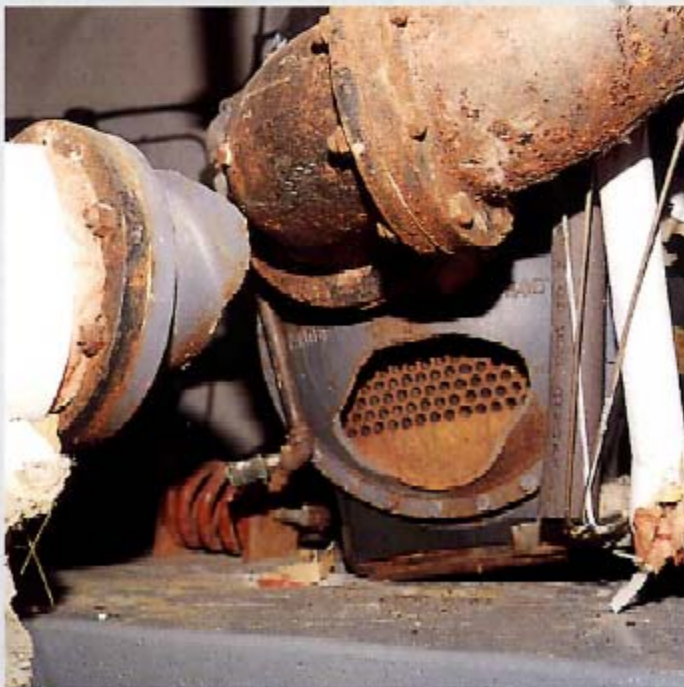
An excellent example of equipment failure at the piping interface. Both the restrained equipment and piping move out of phase during an earthquake and the cast shells are not designed to accept the force necessary to drag the piping. Cast component failures are common. The solution is installation of a spherical twin sphere rubber expansion joint to allow for the motion.

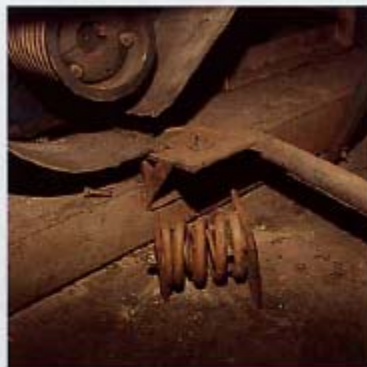
*This close up of the spring shows that the attachment bolt broke allowing the spring to shift and fly free. (The spring was moved back for the photograph.) This would be a dangerous missile anywhere, but particularly in an equipment room with electrical devices. Proper snubbing would have controlled the situation.*

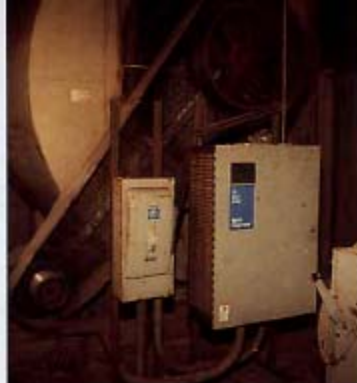
*Spring isolators must be used with seismic snubbers to prevent resonance at seismic frequencies. When the horizontal amplitude became excessive, the whole system shifted releasing the springs while still compressed to 1,500 lb. This sudden release of energy can do damage to anything in the path of the flying springs. Unsnubbed systems not only fail, but they can be dangerous even at low input figures of 0.15gV and 0.12gH.*

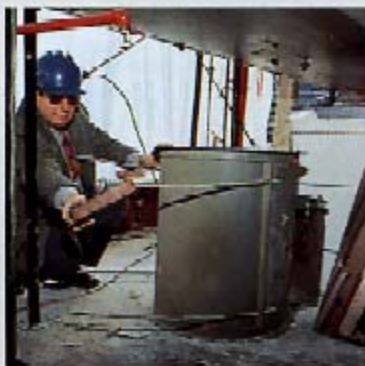
*This small tubular fan broke free of the ceiling and landed on the mechanical room floor. It could have caused severe injury or equipment damage. Electrical lines and control panels are particularly sensitive. This swinging almost always takes place when seismic energy is applied to suspended systems. Proper cable sway bracing would have limited the pendulum action.*

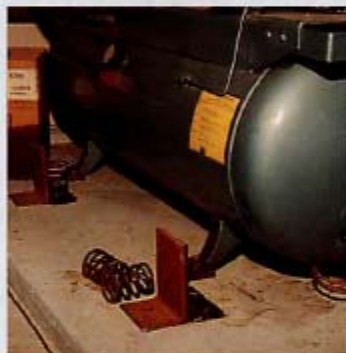
The spring mountings under this air compressor failed, because the snubbers were not all directional. Single bolted restraints can rotate. This angle had a simple pad cemented to one face. The arrangement could only contain the system transversely rather than in all directions. As is typical, the equipment resonated and the springs fell over. Forces were about 0.25g Vertical and 0.35g Horizontal. Proper all directional snubbers would have solved the problem.

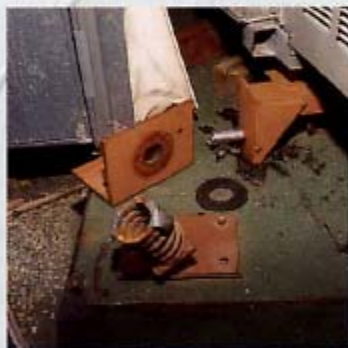
This close up of the SLRA seismic mounting shows that the righthand anchor bolt was distorted at installation and not by the quake. Were it a seismic shift, the other bolt would have been bent as well. The all directional Neoprene collars reduce the impact of steel on steel. (Mason SLRA with extended base plate for anchorage)

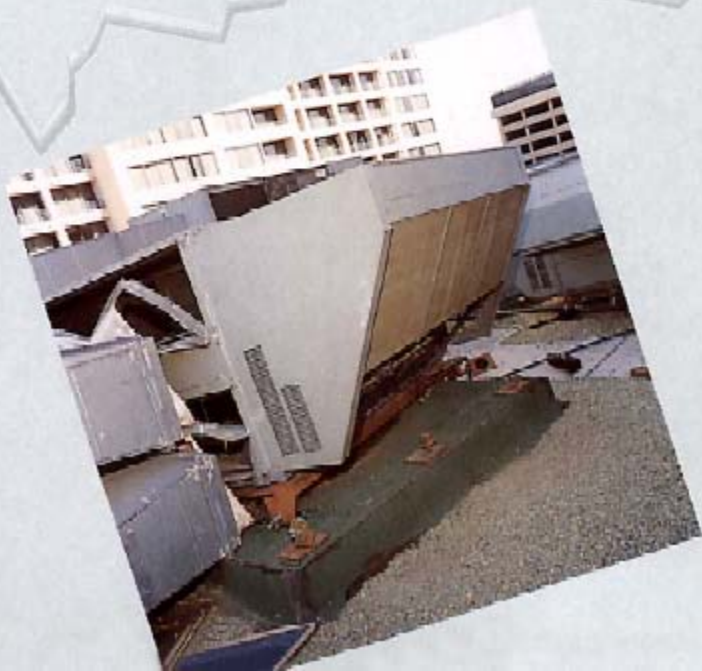
Using a poor copy of a good snubber can result in disaster. Rather than a snubber made with a one-piece double acting, all directional Neoprene sleeve with washer faces, this hard rubber washer was cemented to the angle. The rubber bushing does not appear to be thick enough. The minor cost saving, if any, resulted in a dramatic, costly failure and major equipment displacement.

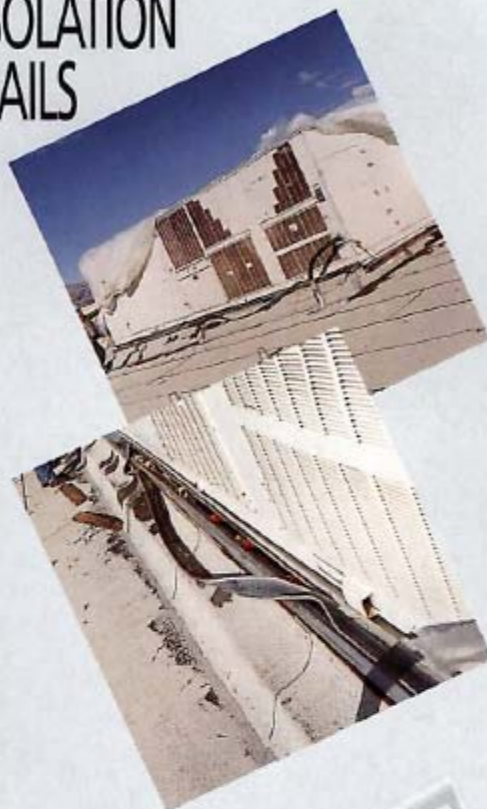
Curb top aluminum isolation bases have very little structural capability and generally fail. These failures are difficult to repair as the roof seldom allows for rigging, and the unit has to be lifted by helicopter or crane before bases can be replaced. Forces were small at 0.1gV and 0.15gH. The problem could have been prevented by using a seismically OSHPD approved complete isolation curb for the same application.

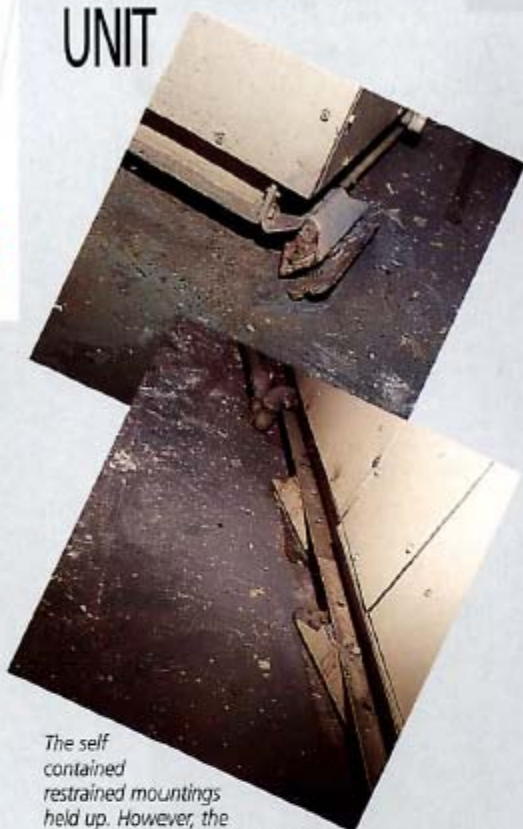
The self contained restrained mountings held up. However, the formed channel base deformed badly and the mounting anchors let go. All of the isolators either rotated or shifted. Part of this problem was the use of slots in the base plates rather than holes. Slotted holes simplify installation, but they are single acting and minor shifts allow one end to escape the anchor bolts and the other to follow. The system would have survived had it been mounted on a steel frame with adequate anchor bolts through base plate holes. Forces were not high at 0.15gV and 0.2gH.

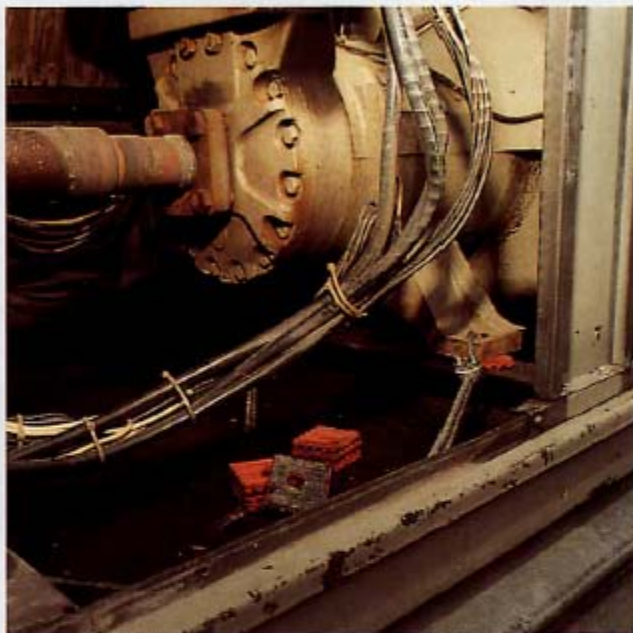
The cable system is an emergency measure to try to keep the compressor in place in anticipation of after shock. Forces were small at approximately 0.15gV and 0.2gH. Equipment with hard mounted internal components and external cushioned seismic isolation systems have a better chance of remaining operative.

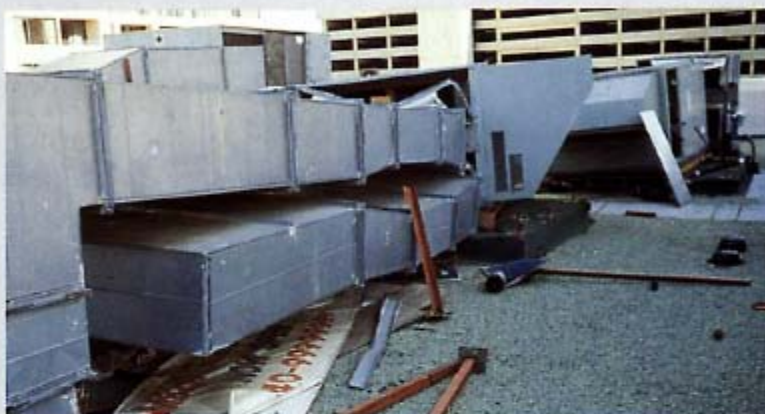
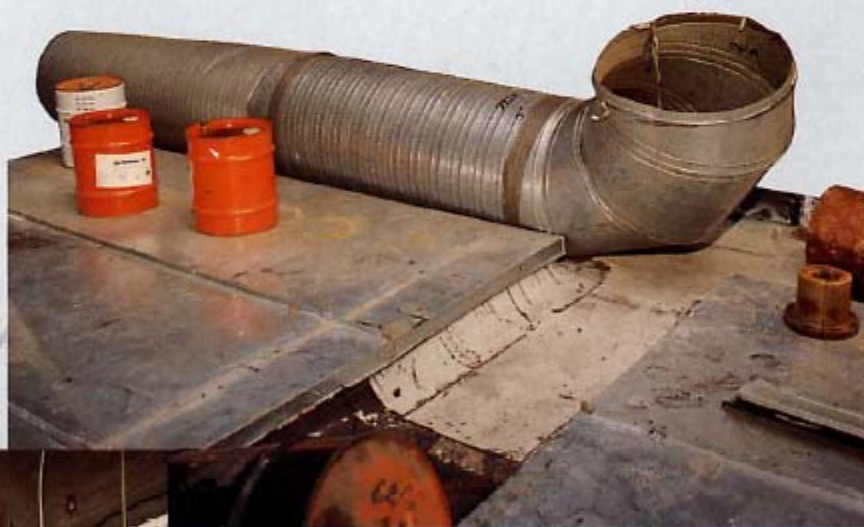
The roof mounted ducts were supported by the steel columns. The four columns were not interconnected, because the loading was so light. However, horizontal forces were large enough to cause failure as the supports were not cross braced to form one integral unit.

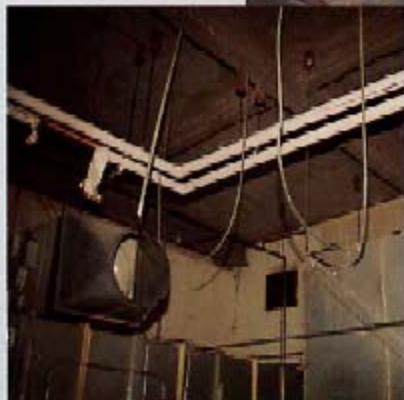
Duct work is very susceptible to seismic damage. Notice the straps that held the ducting that is now on the floor shown in Photograph to the left. This can be prevented by the use of sway bracing to limit sway and keep the duct work in place. Input was 0.15gV and 0.2gH.

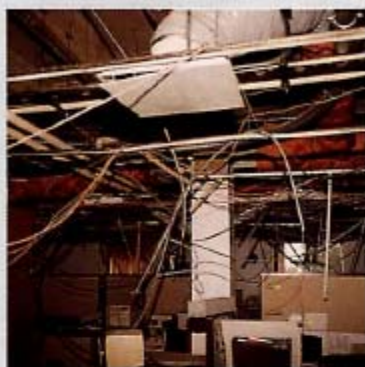
*Suspended ceilings sustained damage in many installations, because sway wires were not used at all or installed improperly. Damage was extensive and very dangerous to people in the spaces below. Fortunately, the earthquake occurred when most offices were not occupied. Forces in this location were 0.2gV and 0.25gH.*

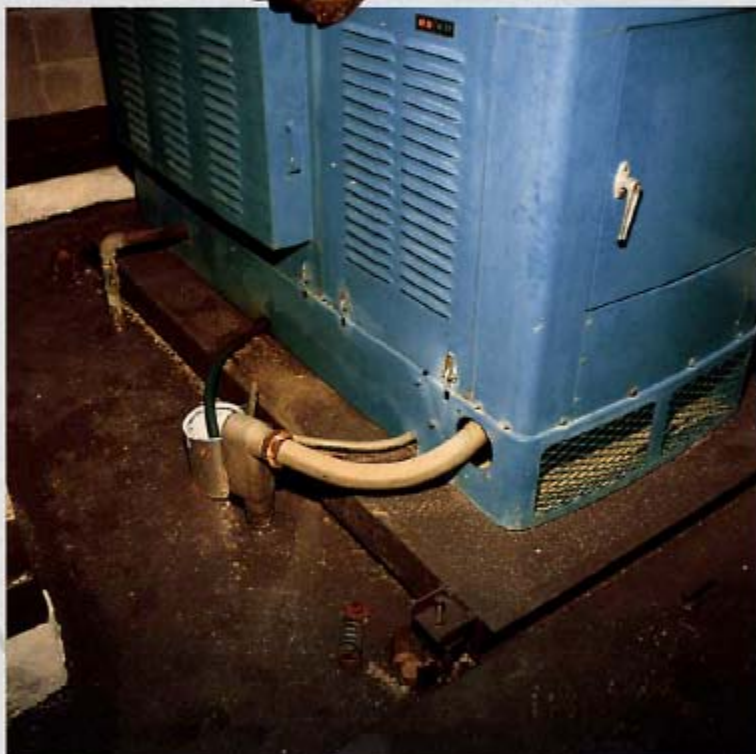
*This is a common but unacceptable method of mounting an emergency generator. The generator was bolted to a concrete floating base and supported on springs within gray iron castings. As in other applications, these castings failed to restrain the generator because both the corner rubber inserts and the springs flew out. This design has no upward restraint either. Of all the equipment, every precaution should be taken so the emergency generator remains operational. Failure was total at the very low levels of 0.1gV and 0.15gH. The steel framed reinforced concrete base looks satisfactory, but the supports should have been spring mountings protected by proper snubbers or springs within all directional ductile housings.*
