A PICTORIAL STUDY OF

# SEISMIC DAMAGE

AND THE USE OF  
PROPER SAFEGUARDS.

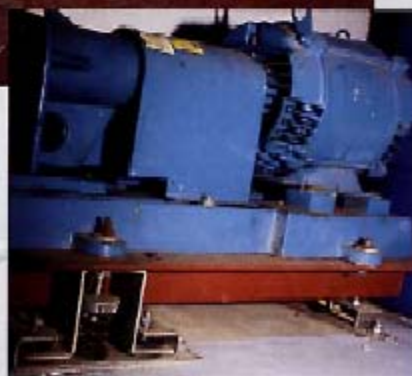
*This pump system is mounted on a steel frame to minimize floor loading. The springs are inside a steel seismic housing with all directional elastomeric grommets to prevent hard surface impact. Anchor bolt edge distance was more than adequate and the system showed no sign of failure. (Mason MSL Base, SLRA Spring Mountings with extended base plates)*

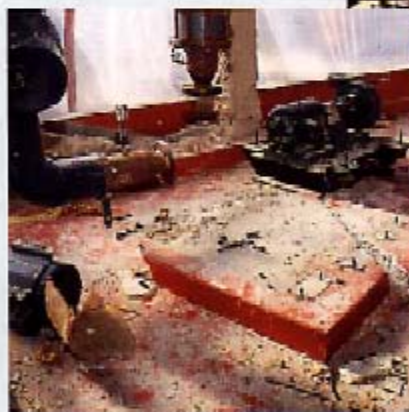
Housekeeping pad failures were common, because of improper doweling or fastening to the structural floor, and inadequate or no reinforcement in the pad itself. These pads, as the pads on the cover, had both problems. Inadequate fastening allows the pads to lift, chatter and shift. Poor reinforcement allows breakage. When the pads fail, the system must fail as nothing remains in place.

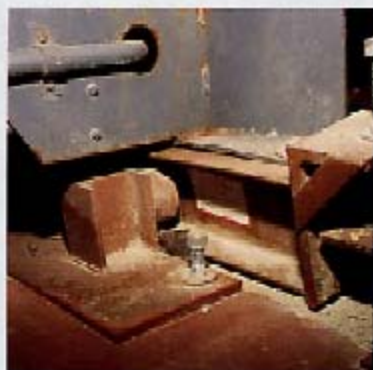
The anchor bolts were too close to the edge of the concrete housekeeping pad for the concrete to offer adequate resistance to the horizontal anchor bolt forces. The edges broke off so the anchor bolts were freed. This total failure of the restraint system occurred at only 0.15gV and 0.15gH. The mountings themselves showed considerable distortion as well.

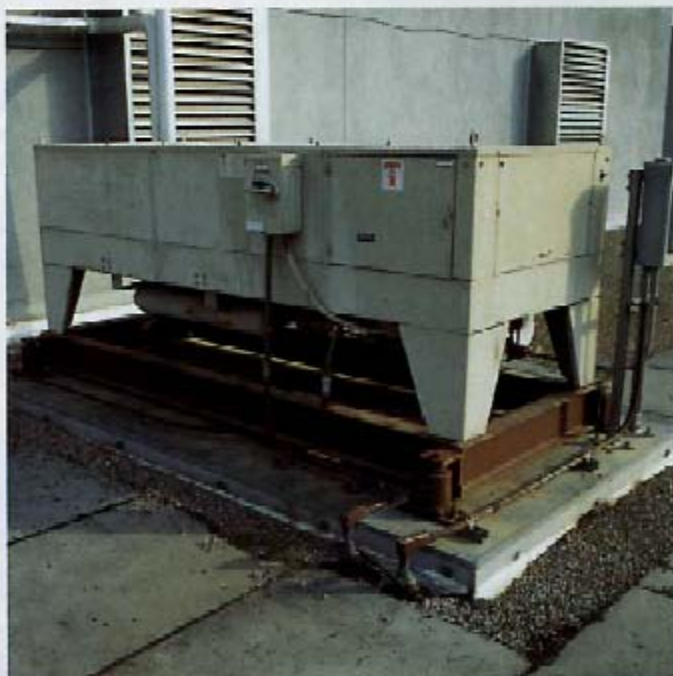
This is an excellent installation using a structural steel frame with height saving brackets and spring mounts with their own built in seismic protection. These are not malleable or gray iron, but ductile castings that will not shatter. The air cooled chiller has very light sheet metal legs which did not buckle, because the steel frame tied the four legs together. This unit was almost at the epicenter of the earthquake and saw seismic inputs of 1.0gV and 1.4gH. These are some of the highest forces ever recorded by an instrument anywhere in the world, but the installation survived intact. (Mason WF Base, SSLH Snubbed Spring Mountings)

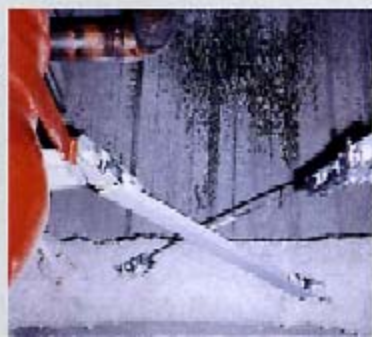
An unusual photograph showing both solid and cable braces. Both systems use swivel fittings specifically designed for the purpose to simplify installation and provide OSHPD approved attachment. Contractors often prefer cable to solid bracing even on non-isolated piping, because cables can be installed more quickly. (Cable Braces Mason type SCB, Solid Braces Mason Type SSB)

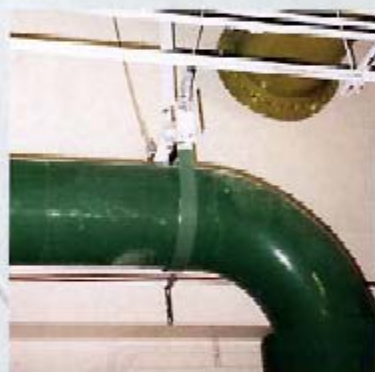
A typical example showing the use of a cable sway brace with swivel fittings for the specific purpose. Fittings are adjustable and the installation simplified by their use. (Mason Type SCB)

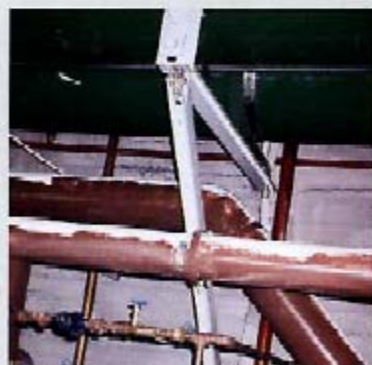
The swivel sway brace fittings at the ends of the angle iron brace eliminate welding, fitting and fabrication time. Solid sway braces can only be used on equipment that is not isolated. When equipment is isolated, bracing must be by cable or isolated devices to prevent transmission of vibration. (Mason SSB)

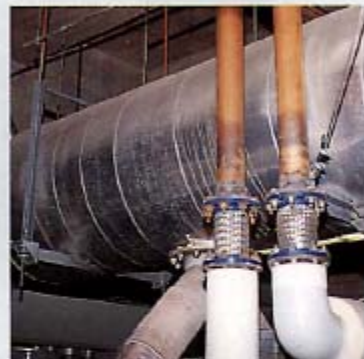
The metal flexible hose prevented pipe failure. However, the metal hose on the right was compressed. Braided metal hoses cannot accept compression and it had to be replaced. Flexible metal joints do not have the same movement capabilities as rubber joints, and tend to fail under seismic conditions. The seismic input was 0.15gV and 0.2gH. (Recommendation: Mason Safeflex SFDEI)

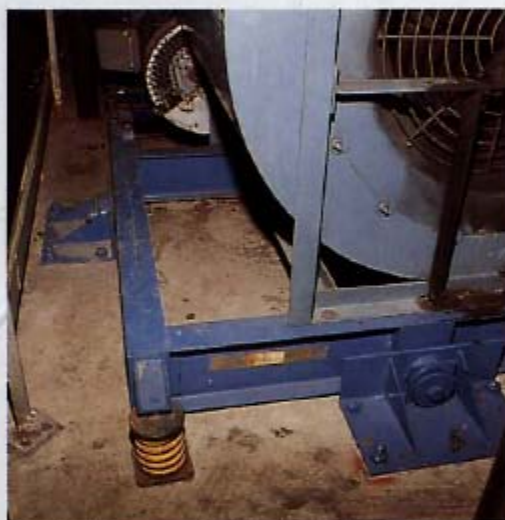
*One of the proper ways to mount a fan and motor is to bolt the equipment to a rigid rectangular steel base. The spring mountings friction pads eliminate the need for bolting as the snubbers will limit motion. All directional thick Neoprene snubber bushings both restrain and cushion shock. (Mason WF Base, SLF Springs, Z-1225 Snubbers)*

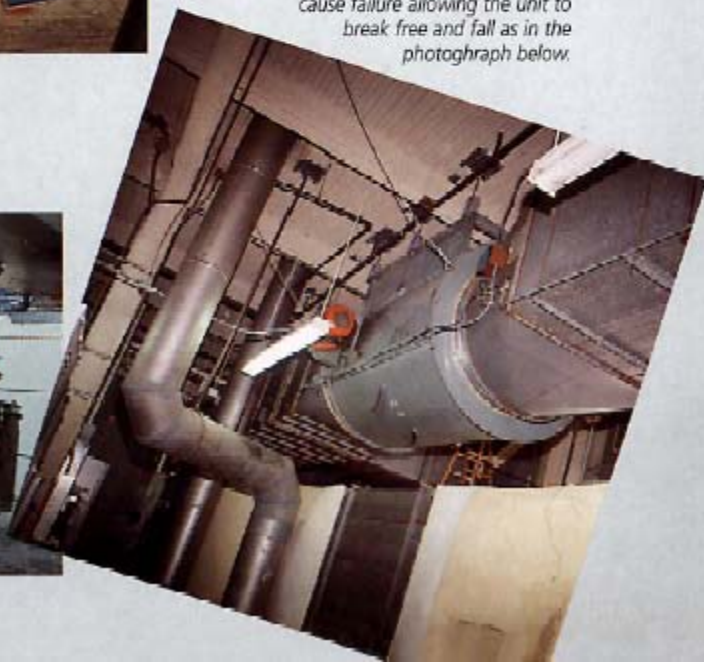
*This small tubular fan broke free of the ceiling and landed on the mechanical room floor. It could have caused severe injury or equipment damage. Electrical lines and control panels are particularly sensitive. This swinging almost always takes place when seismic energy is applied to suspended systems. Proper cable sway bracing would have limited the pendulum action.*

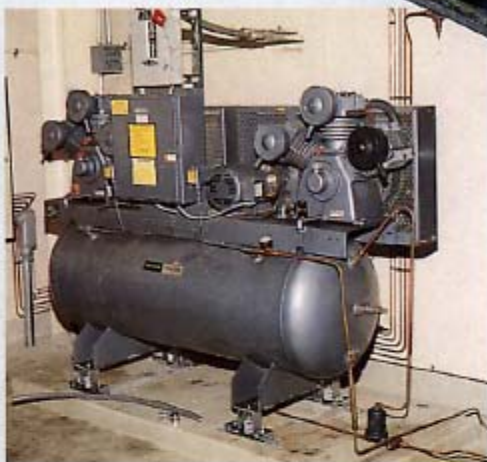
The spring mountings under this air compressor failed, because the snubbers were not all directional. Single bolted restraints can rotate. This angle had a simple pad cemented to one face. The arrangement could only contain the system transversely rather than in all directions. As is typical, the equipment resonated and the springs fell over. Forces were about 0.25g Vertical and 0.35g Horizontal. Proper all directional snubbers would have solved the problem.

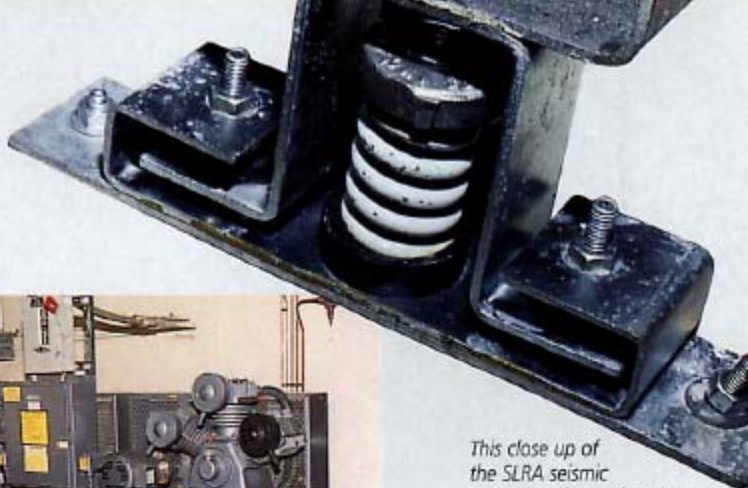
This is a simple isolation method for a horizontal tank mounted compressor (if the base legs are sturdy enough) without the use of a supplementary steel base. Mountings have built in seismic snubbers with ratings from OSHPD in the State of California. Not only these mountings, but similar designs were successful in every reviewed location. Forces were approximately 0.2gV and 9.25gH. (Mason SLRA Mountings)

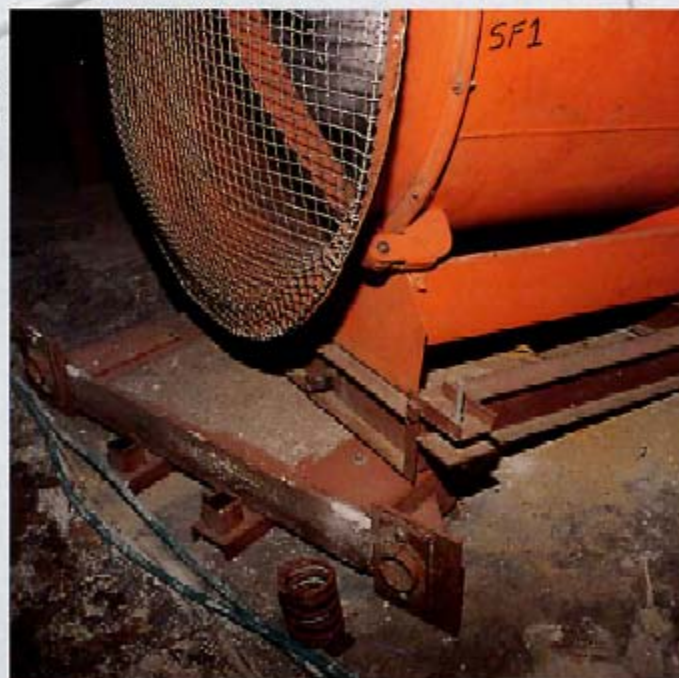
The self contained restrained mountings held up. However, the formed channel base deformed badly and the mounting anchors let go. All of the isolators either rotated or shifted. Part of this problem was the use of slots in the base plates rather than holes. Slotted holes simplify installation, but they are single acting and minor shifts allow one end to escape the anchor bolts and the other to follow. The system would have survived had it been mounted on a steel frame with adequate anchor bolts through base plate holes. Forces were not high at 0.15gV and 0.2gH.

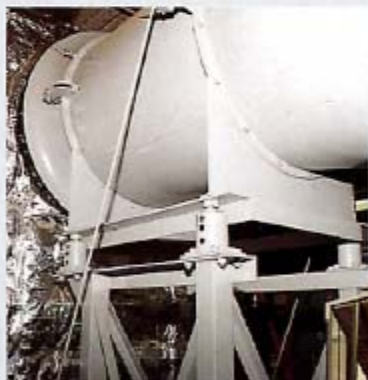
This excellent design uses square steel tubing as the support columns, cross braced by steel angles. The frame was securely fastened to the structure and the isolation positioned on top. Self-contained ductile iron, seismic mountings supported a supplementary steel base under the blower. The system was subjected to very high forces of 1.4gV and 1.2gH with no failure to the system. (Mason Industries' MS Lower Base, SSLFH Ductile Iron Seismic Mountings, MSL Steel Base)

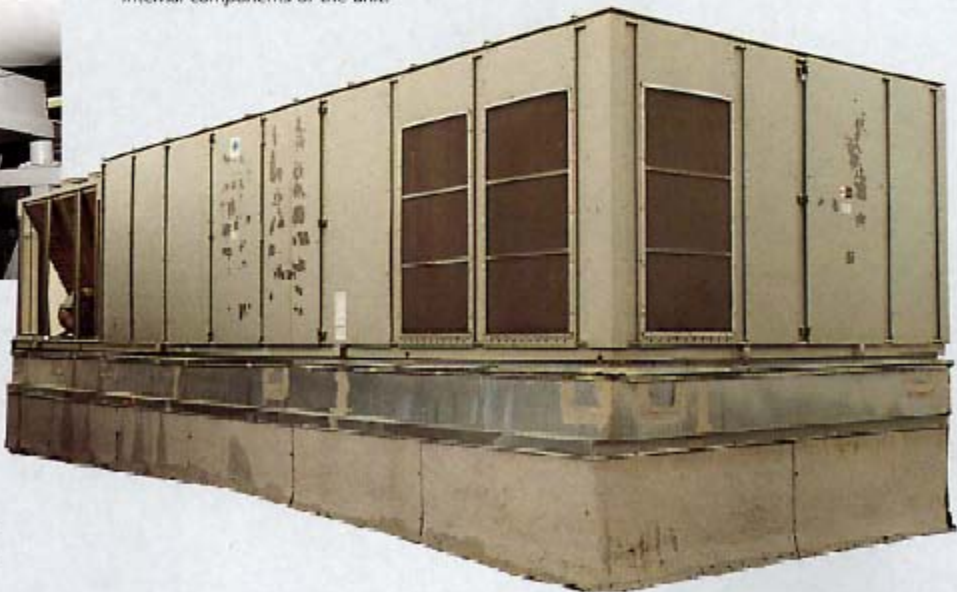
This properly designed seismically rated spring curb had resistances based on testing to allow for seismic input. The input forces were approximately 0.2gV and 0.25gH. The spring curb prevented damage to the lower support curb and the internal components of the unit.

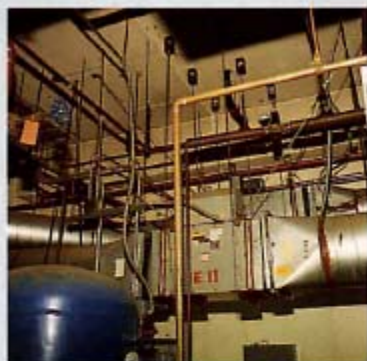
The duct work and piping in this photograph is almost all supported by spring hangers. However, the cable sway bracing kept everything in place and there were no failures in this area.

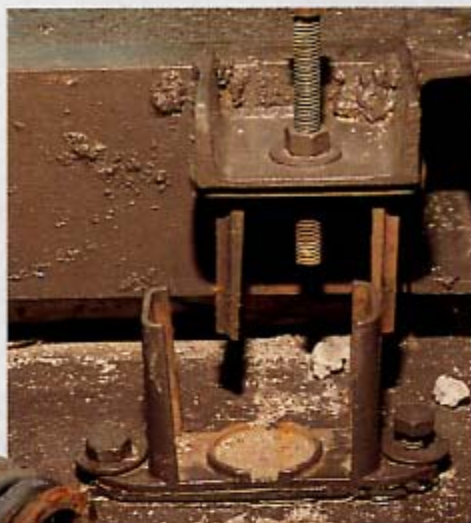
*This is a common but unacceptable method of mounting an emergency generator. The generator was bolted to a concrete floating base and supported on springs within gray iron castings. As in other applications, these castings failed to restrain the generator because both the corner rubber inserts and the springs flew out. This design has no upward restraint either. Of all the equipment, every precaution should be taken so the emergency generator remains operational. Failure was total at the very low levels of 0.1gV and 0.15gH. The steel framed reinforced concrete base looks satisfactory, but the supports should have been spring mountings protected by proper snubbers or springs within all directional ductile housings.*
